Subject: Pilot Bearing Spacer 02-14069-000 – Detroit Diesel Engines

Document Number: TAIB-0854

Issue Description: Reduced transmission input shaft support caused by insufficient engagement of the pilot bearing on Detroit Diesel engines.

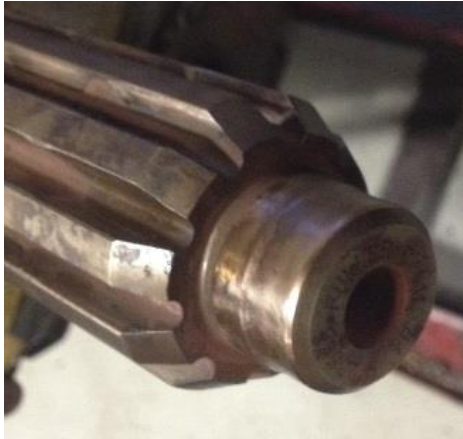
Worn input shaft pilot surface

- Install spacer 02-14069-000 between the flywheel and a new pilot bearing when the transmission is removed for service work.
- Inspect the transmission input shaft pilot surface and oil return threads (see picture below). Replace the input shaft if there is evidence of any wear at these locations or the transmission was leaking oil at the front bearing cover before it was removed.
- Replace the transmission front bearing cover if the input shaft oil return threads are damaged.
- Remove shift bar housing and inspect the main drive gear set for tooth damage before placing the transmission back in the vehicle. Replace any damaged gearing.

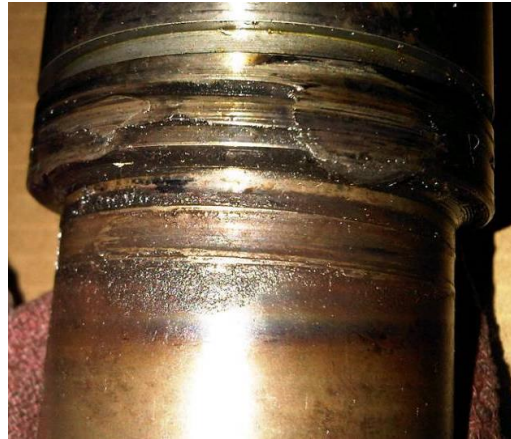
Damaged oil return threads
